To: Christopher Johnson, P.E.
Associate Vice President
Project Manager
Carollo Engineers, Inc.
12592 W. Explorer Dr., Suite 200
Boise, ID 83713

Re: Preliminary Analysis of Fresno Corrosion Issue and Recommendations (Draft)

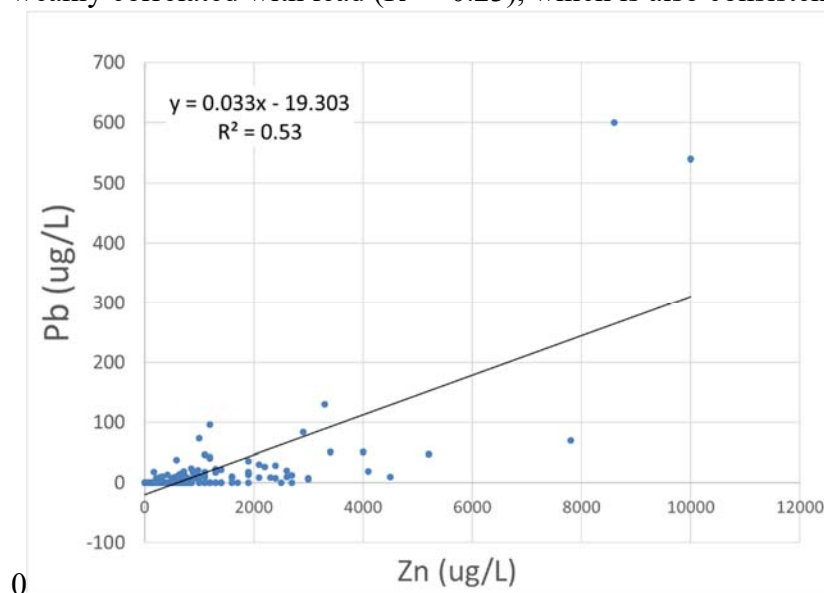
Figure 1. Moderate correlation between Pb and Zn in Fresno water samples. The slope of 0.033 indicates that in a typical home, lead will be about 3% of the zinc content.

GI-Pipe could be a modest risk factor for higher lead in Fresno cold drinking water. Using data provided by Fresno for samples collected predominantly from hot water, there is a moderate correlation ($R^2 = 0.54$) between lead and zinc in water (Figure 1). The slope indicates that in a typical home, lead released to water will be about 3% of the Zn released to water by weight. This is roughly consistent with the ratio of lead to zinc found in GI-pipe coating. Iron was also weakly correlated with lead ($R^2 = 0.23$), which is also consistent with a GI-pipe source.

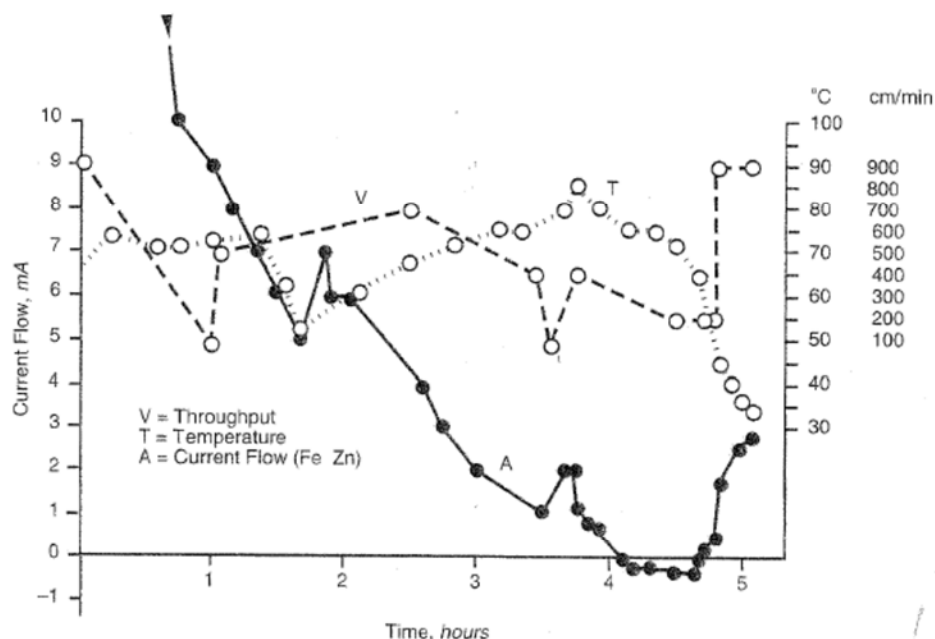
Source: Schikorr (1939).

Figure 3-24 Potential reversal of iron and zinc in a circulating hot-water loop

Pitting as a result of potential reversal. Schikorr (1939) was the first to demonstrate that the relative potentials of zinc and iron can be reversed at higher temperatures. He also demonstrated that the reversal is accomplished primarily by shifts in the potential of the zinc surface and that iron's potential remains relatively stable. Figure 3-24 summarizes some of Schikorr's results, showing the current flow between iron and zinc electrodes (briefly connected for each measurement) and the temperature and velocity during the test. The authors of this chapter have confirmed this phenomenon in their laboratories, as have most of the investigators cited earlier. It has been shown to be a function of water quality, oxygen tension, and temperature.

In hot water, the surface scale of zinc apparently changes, forming a scale that more effectively supports the reduction of oxygen at the cathode and that "heals" some of the anodic sites, reducing the anodic area. Gilbert suggested that zinc might have a hydroxide scale at low temperatures and a zinc oxide scale at higher temperatures. This process has little effect on the overall corrosion rate of zinc, but the increased polarization of the anodic sites due to their reduced area and the more effective depolarization of the cathodic sites due to the greater conductivity of the new scale substantially increase the potential of the zinc, making it more noble than the iron. As a result, any exposed iron becomes anodic and severe pitting begins. In soft water, no scale is deposited and the pitting attack will continue until the pipe wall is perforated. In hard, scale-forming water, if the conditions are
